Cracked Pipe

By: Inspector Weeks 613.290.3697

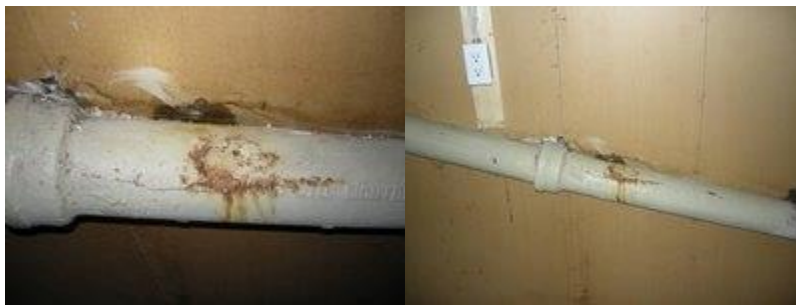
We recently purchased an older home with what looks to be a metal drain pipe that is visible in the basement. There appears to be a crack as well as rust on the pipe. Although it seems dry, should I be concerned? Anne J. Aylmer, Quebec.

Yes, you are right to be concerned and thanks for the pictures. The pipes in the pictures are made of cast iron. Older cast iron pipes tend to be brittle and when put under stress will crack. The crack and the rust have obviously been there for a while and fortunately are on the top side of the pipe. For that reason the actual leakage of water from the pipe is only occasional as most of the time the flow of water is only along the lower half of the pipe. This pipe is more than likely a main sewage drain line. For health and safety reasons, my recommendation would be to replace the pipe right away. You have the option of replacing it with new cast iron pipe or cutting out the damaged area and replacing it with ABS plastic pipe with the correct fittings. With cast iron pipe you will hear less of the flow of the water, but considering it is in a basement ABS pipe would make a fine replacement at a lower cost. Be sure to take a good look at the rest of the exposed pipe for any other cracks or leaks and have them fixed at the same time. This kind of repair is best done by a professional.
